CITY OF BELOIT

REPORT TO THE BELOIT LANDMARKS COMMISSION

File Number: COA-2015-23

Location: 816 Wisconsin Avenue

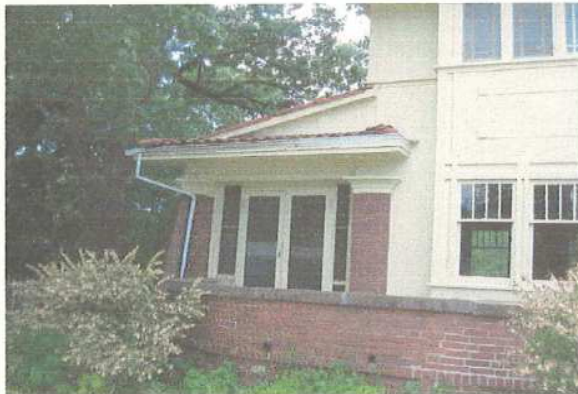
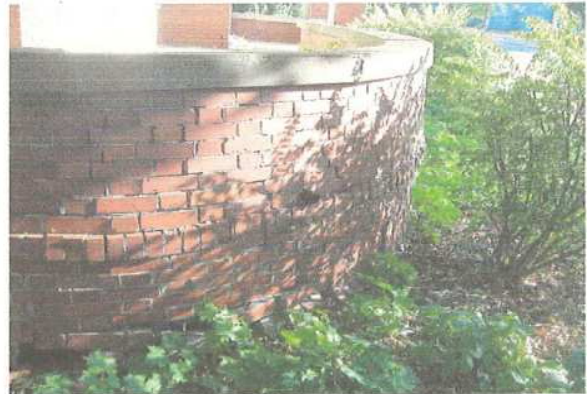
The curved front porch has suffered severe damage due to missing footings, allowing water to seep up from the ground level; previous poorly completed reconstruction and repairs; and from a concrete layer being added, covering the original brick pattern. Damage to one section of the layer of concrete reveals a small portion of the original brick.

Above can be seen two views of the front porch showing the overall deterioration of appearance and integrity.

The porch is to be completely restored on top of a 6 inch footing. All bricks and limestone caps are to be removed, numbered, cleaned, and then relaid down to the footing, including the paver bricks beneath the concrete. Front porch wing walls to be removed, numbered and relaid. New front steps under each wing wall to be restored. Paint removed from all brick. If exterior brick is damaged so as to mar the front façade appearance, it will be replaced with undamaged brick from the interior of the porch curve. The interior will use all matching new brick of the same size and color as the original. All new will be used on the inside of the porch only, to prevent a mottled, patchwork appearance.

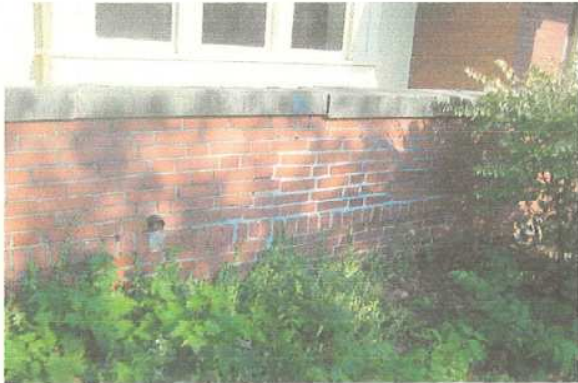
Above left shows the portion of the front porch that was previously deconstructed and improperly reconstructed. The bricks in that section have been painted. Above right is the right side of the porch.

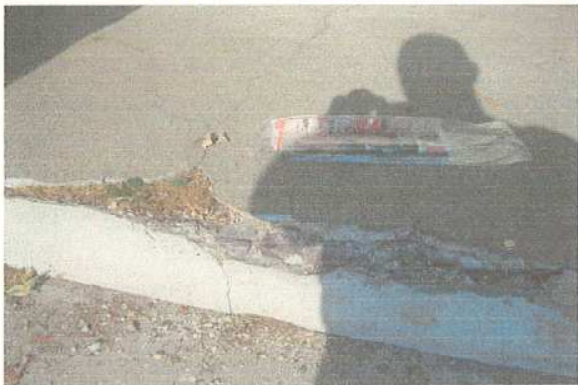
Above left can be seen the damaged concrete on the front steps, revealing a portion of the underlying paver bricks. Above right is a view of the internal section of the porch.

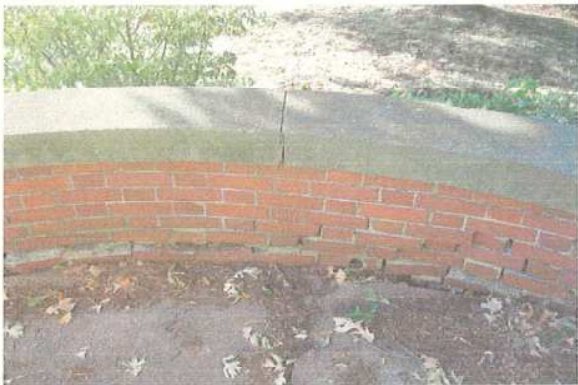
Above left is another view of the inside curve of the front porch. Above right the color of the mortar can be seen to be darker in the protected areas, having been originally colored with coal dust.
