CITY OF BELOIT

REPORT TO THE BELOIT LANDMARKS COMMISSION

File Number: COA-2014-12

Location: 726 Church Street, 619 College Street, 815 College Street, 717 Emerson Street

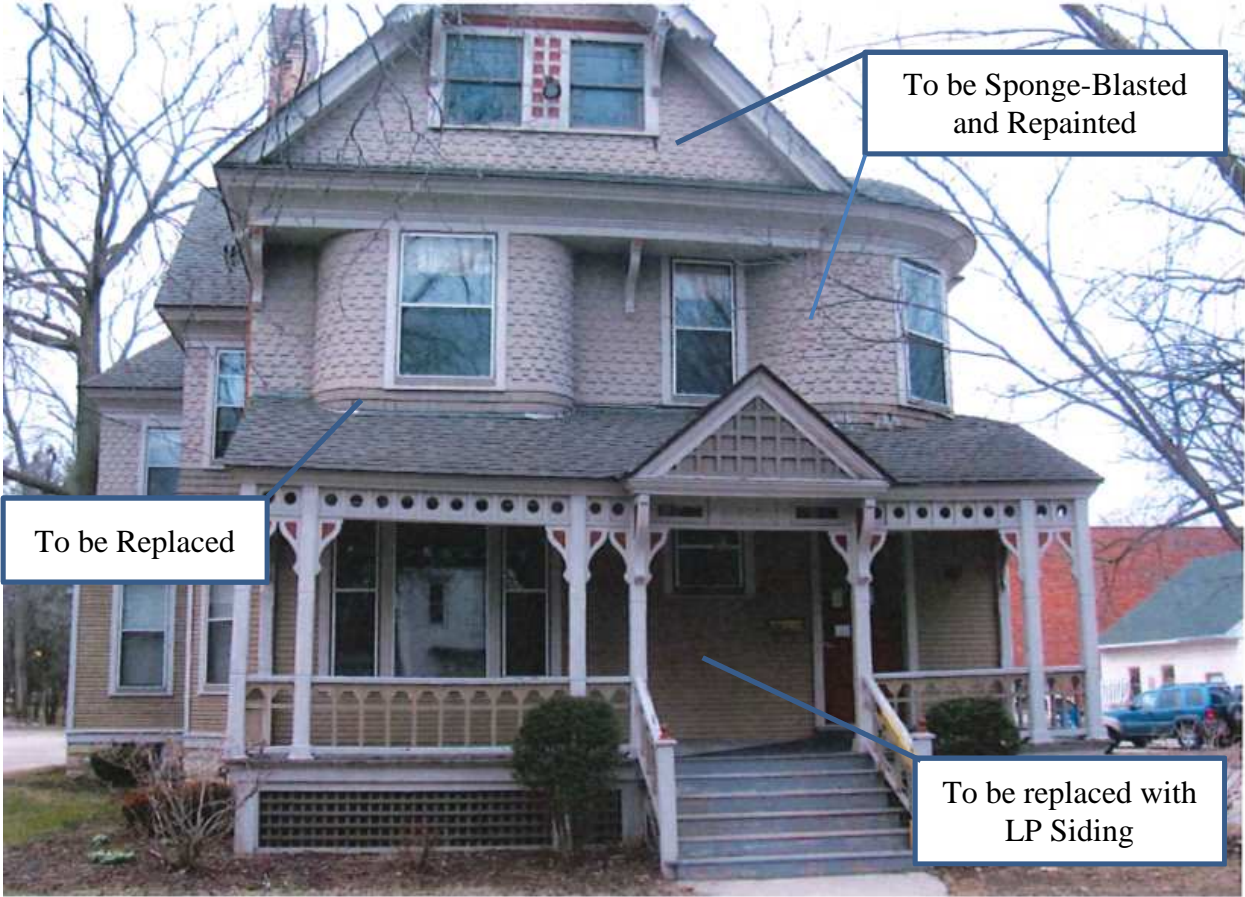
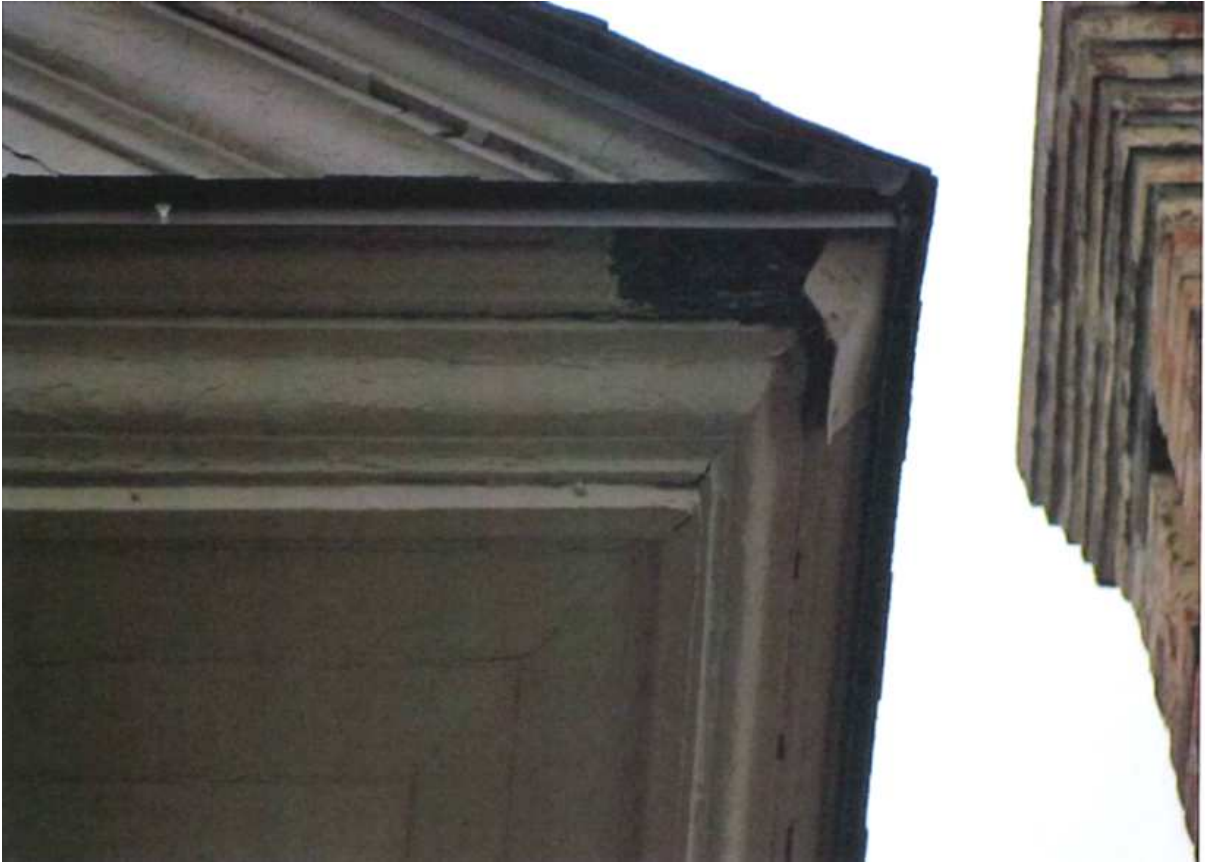
To be Sponge-Blasted and Repainted

To be Replaced

To be replaced with LP Siding

- The applicant is proposing to replace the first-level siding and window frames with LP siding material to match the existing design and color. All upper-level siding will be sponge-blasted for cleaning and then repainted. Spot shingle, soffit, and window sill replacements will be done as needed with like materials. The middle shake siding that separates the first and second level will be replaced with like materials.

1. This COA does not include any work for the building located at 815 College Street.
2. Spot-testing shall be done with the sponge-blasting paint removal system at 726 Church Street to verify that this method is not damaging to the property prior to sponge-blasting the entire property. This shall be verified by Planning Staff.
3. All work shall be completed by May 20, 2015.
4. Any changes or additions to this Certificate of Appropriateness must be reviewed and approved by staff prior to the start of any work. Work done without prior approval will be subject to the issuance of correction orders or citations.

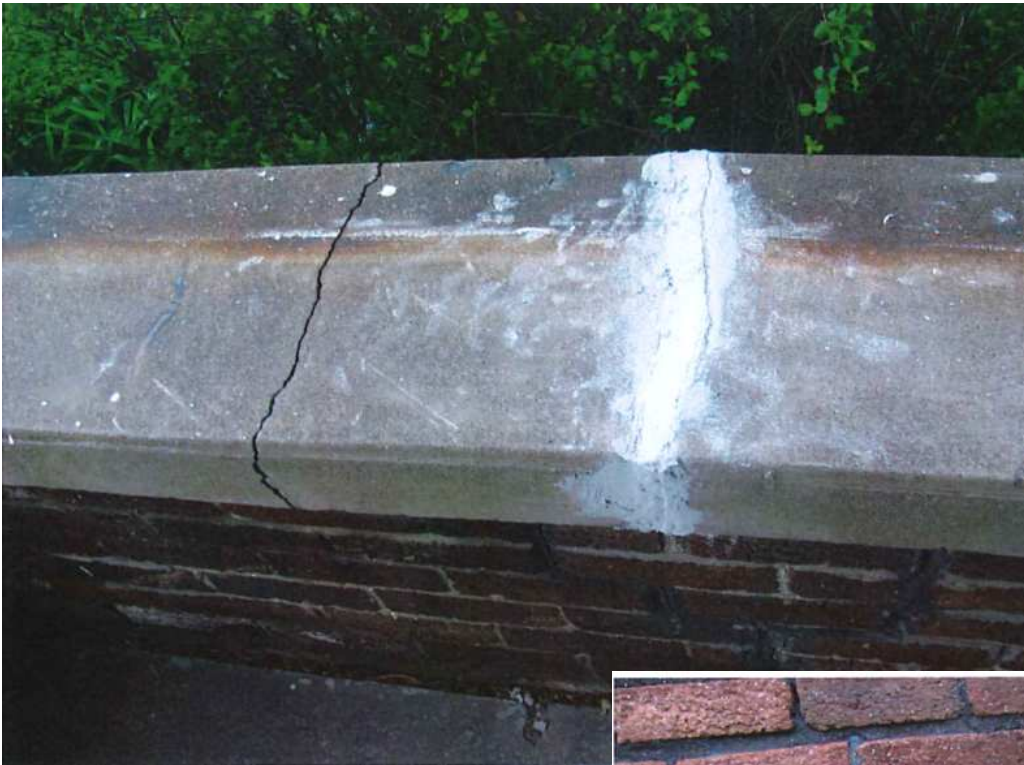
**619 College Street,
Porch Repairs**

- The applicant is proposing repairs to existing brick walls, tuck pointing, and concrete cap replacement to the front porch of this property. The applicant may potentially replace the concrete stairs and decking.

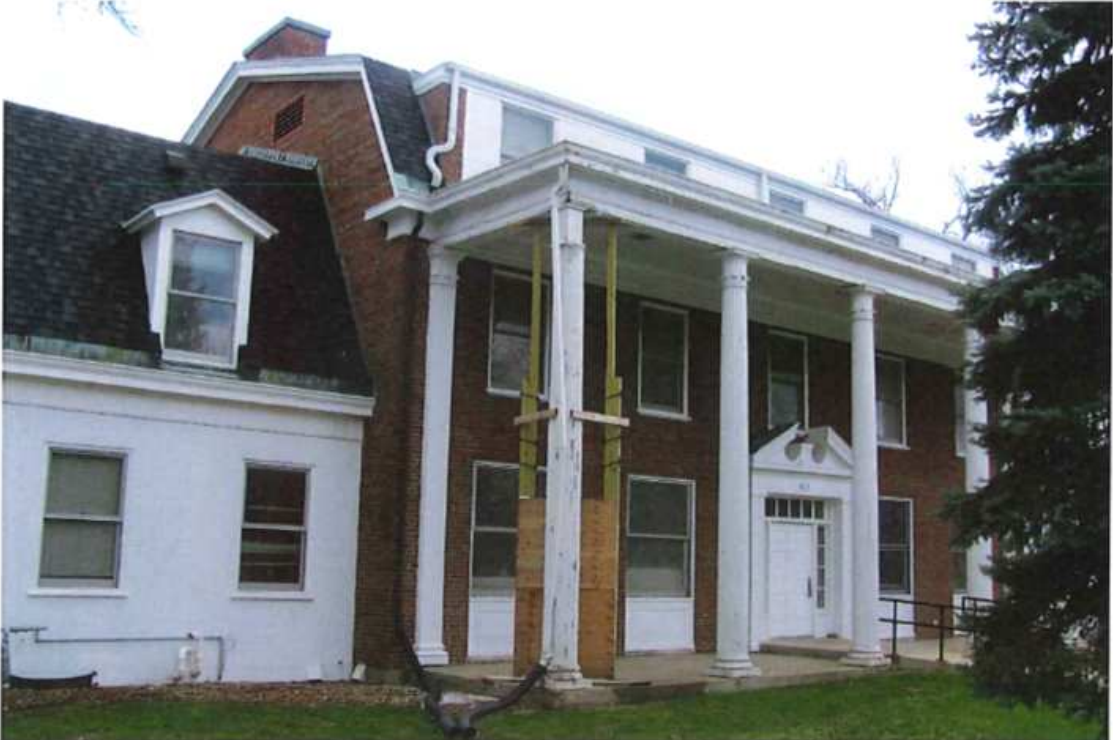
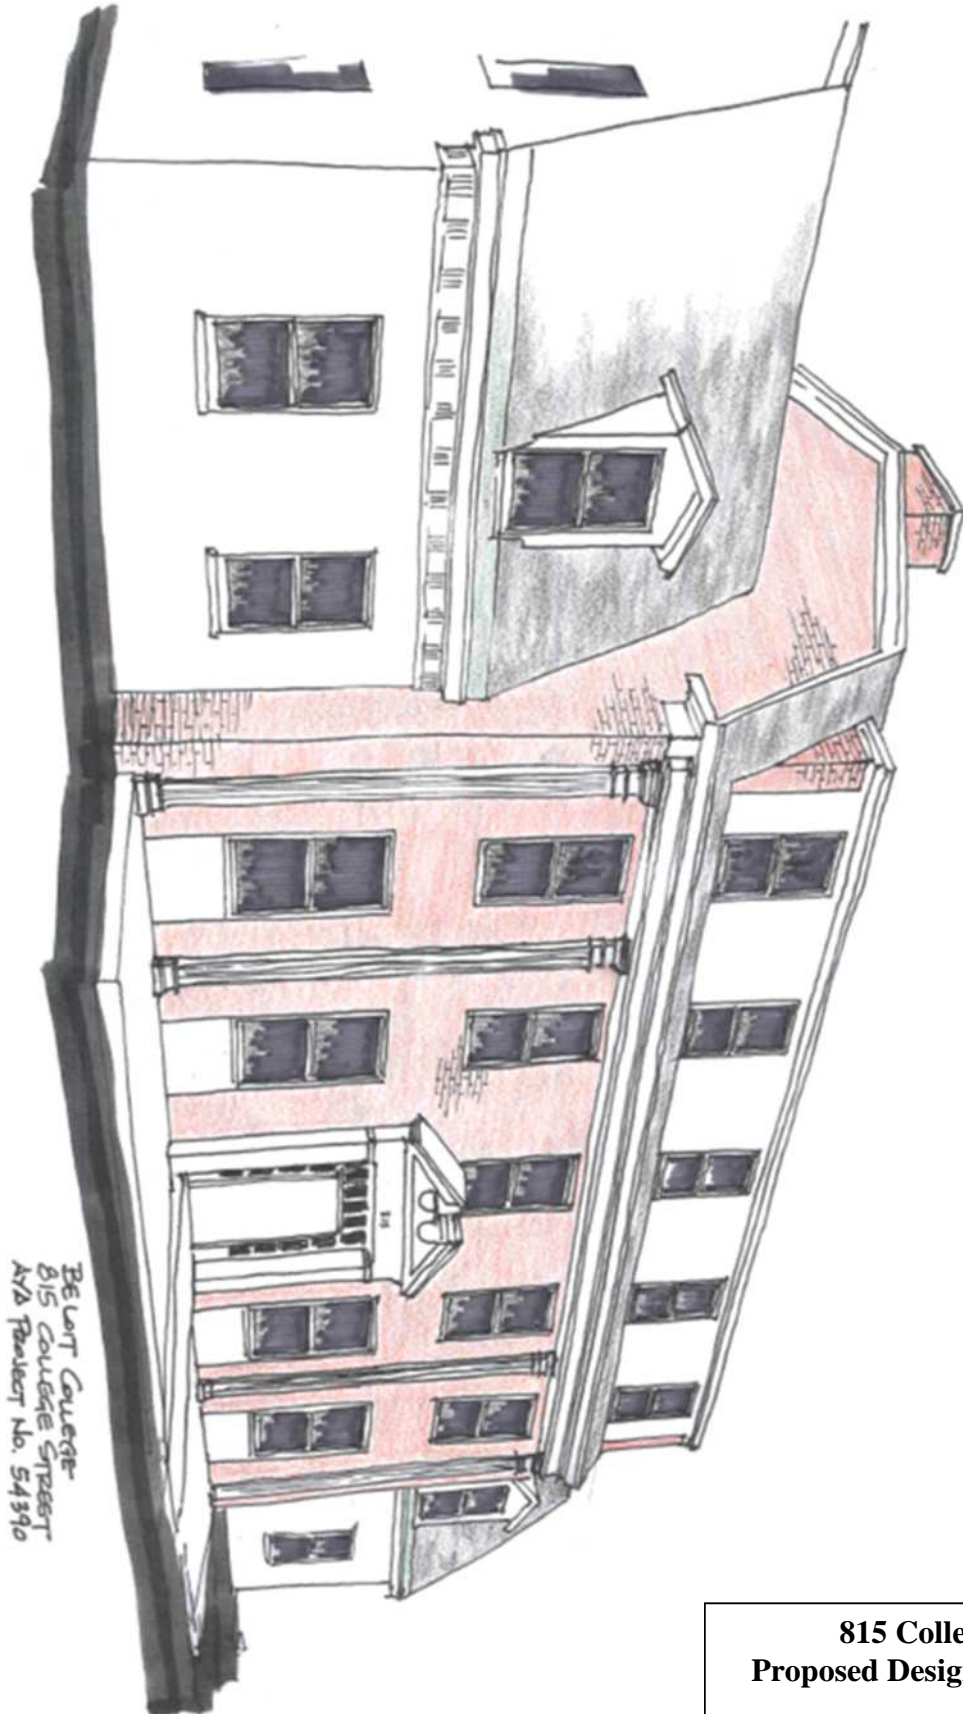
**815 College Street,
Proposed Porch Removal**

- The applicant is proposing removing the two-story front porch from the building, citing the cost to repair (estimated \$40,000) as excessive in comparison to the cost to remove (estimated \$21,000). The porch shows obvious deterioration to the columns, but do not appear to be a safety hazard or beyond repair. The Intensive Survey Form notes an "awkward balustrade on top of veranda roof" which has already been removed. The porch was not noted beyond this comment in the Survey other than to say the columns are similar to that of Chapin Hall. The column porch is present throughout campus.

- With the removal of the porch, the third-level roof would be exposed. Other buildings on campus with porches similar to the proposed porch have windows with individual dormers, not a block-design like the subject property. Between this and a lack of hardship to justify removal of the porch, Staff is recommending denial of this portion of the COA.

This project will remove the existing front porch and replicate the east side roof and fascia. There would also be the option of adding two decorative columns to the west exposure

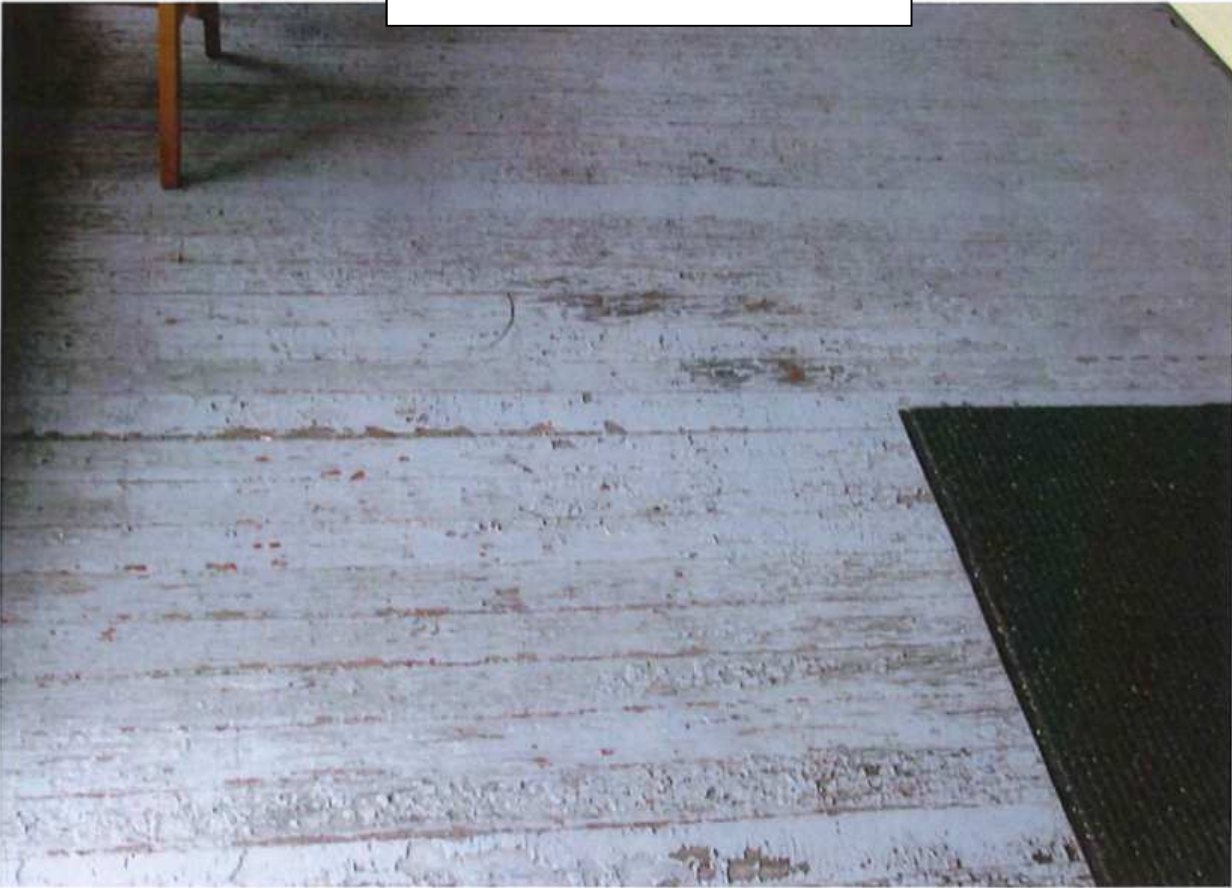
**717 Emerson Street,
Porch Repairs**

- The applicant is proposing repairing and restoring the porch floor and painting it. Replacement of the stairs and handrails is also proposed.
- The proposed site improvements satisfy the standards of Section 32.06(6)(c) of the Historic Preservation Ordinance.

This project will repair and restore the porch floor and paint it painting, as well as replace the existing stairs and handrail.
