CITY OF BELOIT

REPORT TO THE BELOIT LANDMARKS COMMISSION

File Number: COA-2009-12

Location: 743 Park Avenue

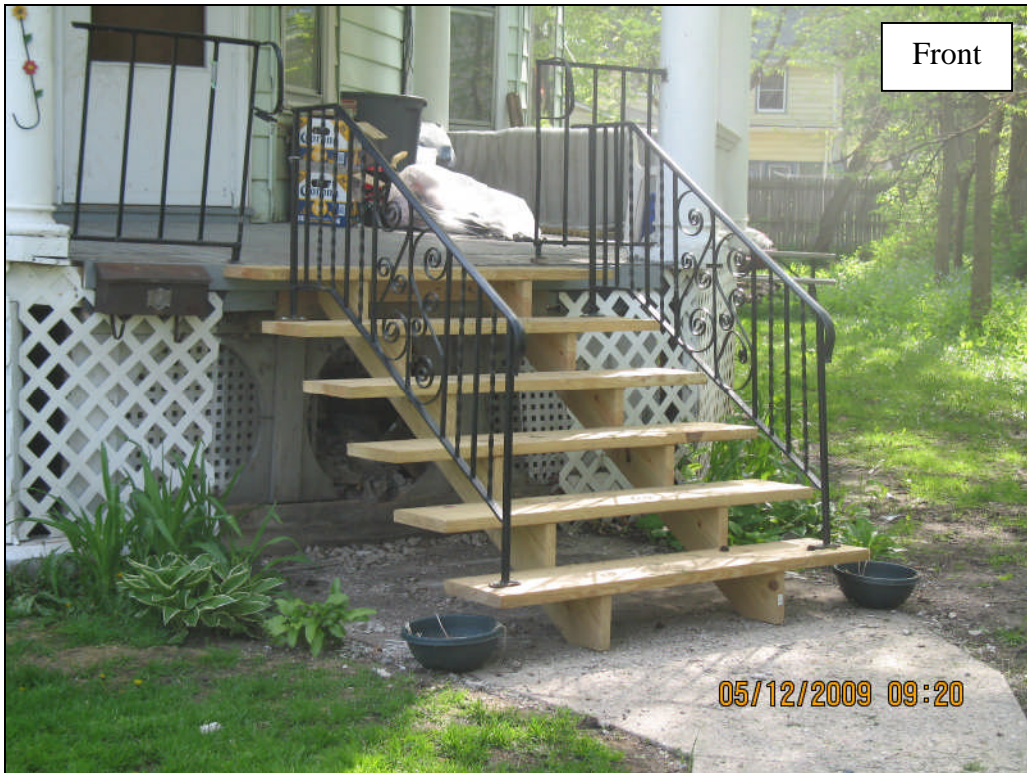
Front

- The massive front porch is a major feature of this historic structure. While the treated wood steps do not violate the building code, they are not appropriate in a historic district. The exposed gap in the porch skirt, the visible open space beneath the steps, and the overall style of the replacement steps are not compatible with the character of the structure or the character of the historic district.

- The steps appear out-of-place next to the decorative columns that support the porch.
- During the Beloit Intensive Survey, the house was classified as a 'contributing' structure within the College Park Historic District. A copy of the Intensive Survey Form is attached to this report.

The Neighborhood Planning Division recommends **denial** of a Certificate of Appropriateness to replace concrete steps with treated wood steps for the property located at 743 Park Avenue, based on inconsistency with the Historic Preservation Ordinance. Denial of the Certificate of Appropriateness means that the applicant is ordered to restore the property to its prior appearance by replacing the treated wood steps with concrete steps. Staff recommends a compliance date of August 1, 2009.

1. The applicant shall replace all wrought iron railings with wood railings that match the railings on the property located at 751 Church Street.
2. All railings and steps shall be painted white.
3. The applicant shall install a porch skirt behind the steps and shall remove all of the remaining pieces of concrete.
4. Prior to painting, the applicant shall enclose the steps to completely conceal the area below the steps.
5. All work shall be completed by August 1, 2009.
6. Any changes or additions to this Certificate of Appropriateness must be reviewed and approved by staff prior to the start of any work. Work done without prior approval will be subject to the issuance of correction orders or citations.
7. The applicant must obtain all necessary building permits. The completion date above does not extend any other time limits, such as those imposed by an order from Housing Services.

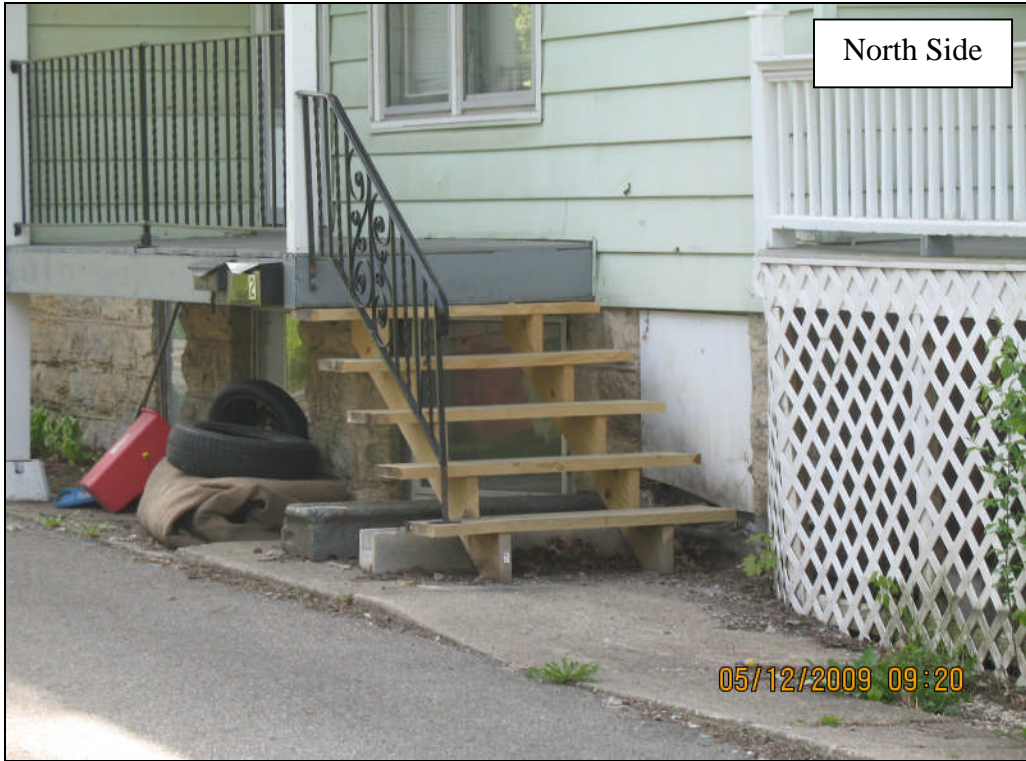
North Side

- Several photos of the subject property are attached to this report. As shown in the photos, the applicant reused the railings.
- If the requested COA is approved, the applicant will replace the existing wrought iron railings with wood railings that are similar to the wood railings on the property located at 751 Church Street (see the attached photo).
