CITY OF BELOIT

REPORT TO THE BELOIT LANDMARKS COMMISSION

File Number: COA-2012-02

Location: 743 Park Avenue

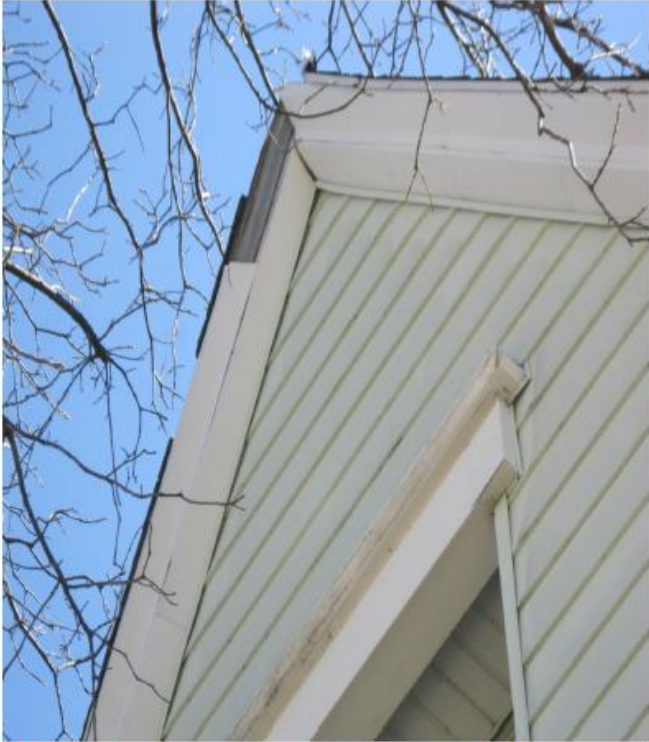
- The applicant has removed all bargeboard panels on the gable located on the west side of the house
- During the Beloit Intensive Survey, the building was classified as a 'contributing' structure within the College Park Historic District. A copy of the Intensive Survey Form is attached to this report.

Missing bargeboard panel on west side of the property. Photograph taken by Code Inspector on March 30, 2011.

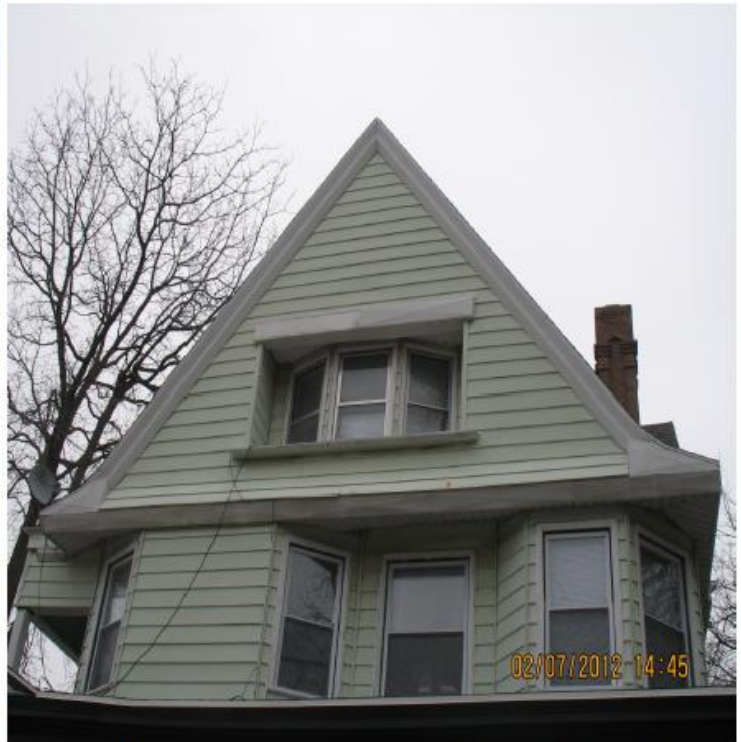
Removed bargeboard panels on gable located on the west side of the property.

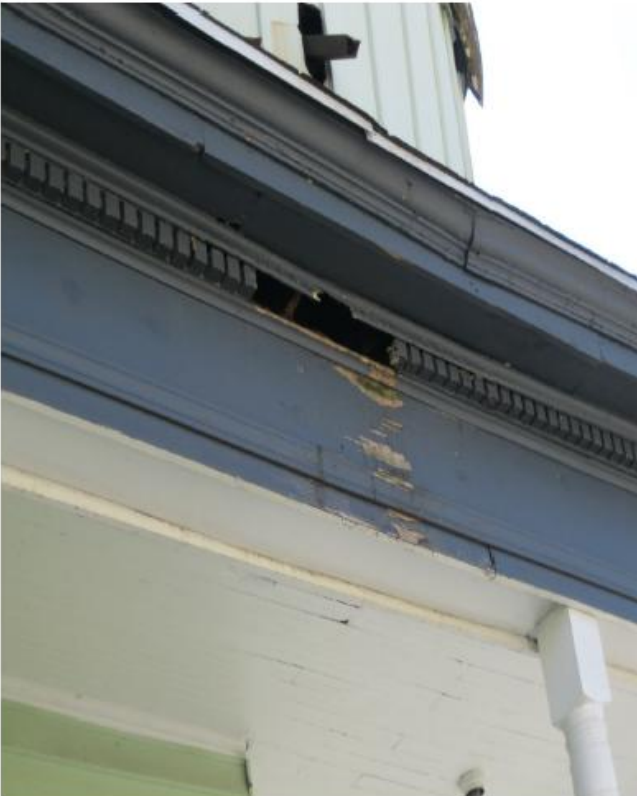
Missing ornamental trim on veranda on the northeast side of the property. Photograph taken by Code Inspector on March 30, 2011.

5. The applicant shall install white aluminum trim on the balcony in a workmanlike manner.
6. The ornamental trim on the veranda shall be repaired and painted to match the existing paint color on the veranda in a workmanlike manner.

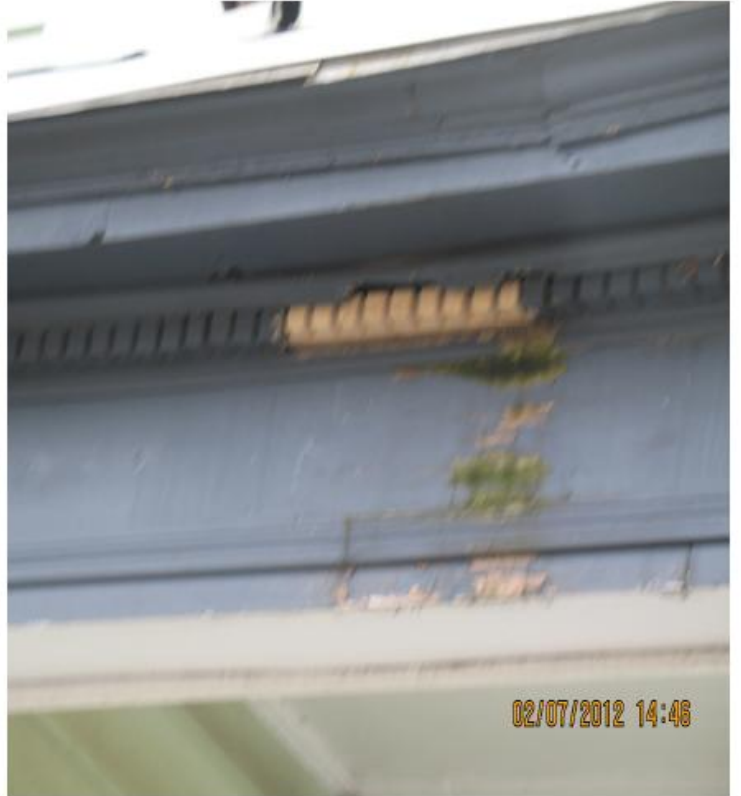
- The applicant has replaced a missing portion of the ornamental trim on the veranda, located on the northwest side of the house, with wood and has proposed to use a satin based "gray-flannel" color to paint it.

Replaced ornamental trim on veranda on the northeast side of the property.

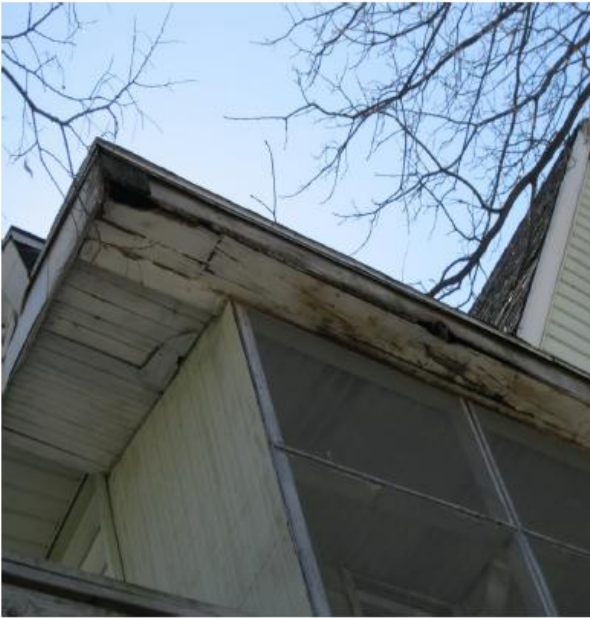
Rotten soffit and fascia boards on the northeast side of the property. Photograph taken by Code Inspector on March 30, 2011.

1. The applicant shall install Main Street Double 4” Woodgrain Clapboard vinyl siding that is “mint” in color in a workmanlike manner.
2. The applicant shall remove the unauthorized white aluminum soffit and fascia panels and verify with the Code Inspector that deteriorated wooden soffit and fascia boards have been repaired or replaced in a workmanlike manner.

3. The applicant shall install the white aluminum soffit and fascia panels in a workmanlike manner.
4. The applicant shall remove the unauthorized aluminum trim on the balcony and verify with the Code Inspector that the deteriorated wood has been repaired or replaced in a workmanlike manner.

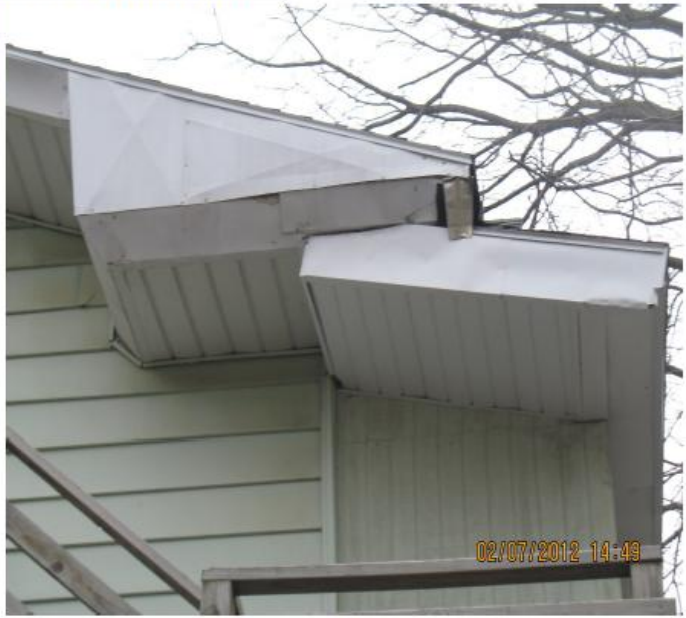
- The applicant has covered the deteriorated wooden soffit and fascia boards on the northeast side of the house with aluminum fascia and soffit panels.

Soffit and fascia panels on the northeast side of the property.

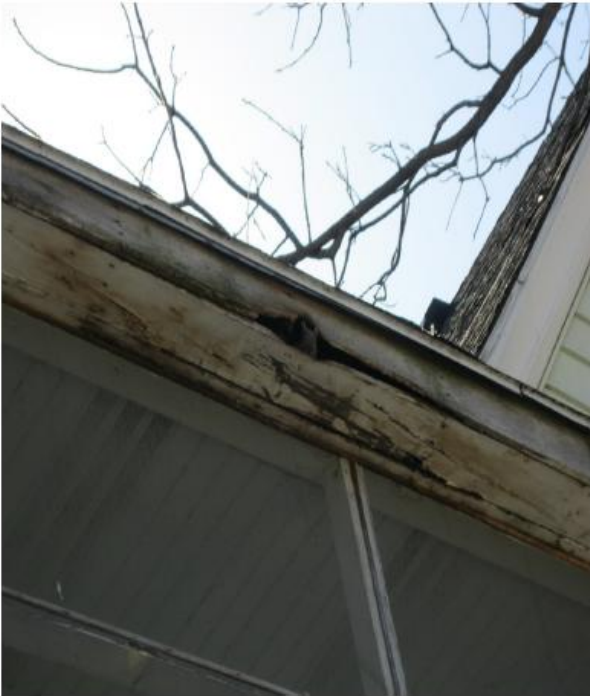
Rotten soffit and fascia boards with squirrel in hole on the northeast side of the property. Photograph taken by Code Inspector on March 30, 2011.

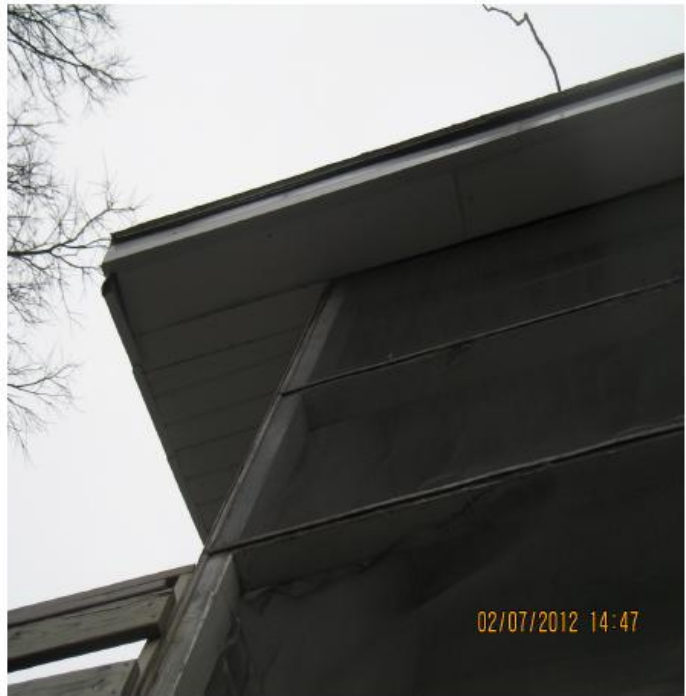
Soffit and fascia panels on the northeast side of the property.

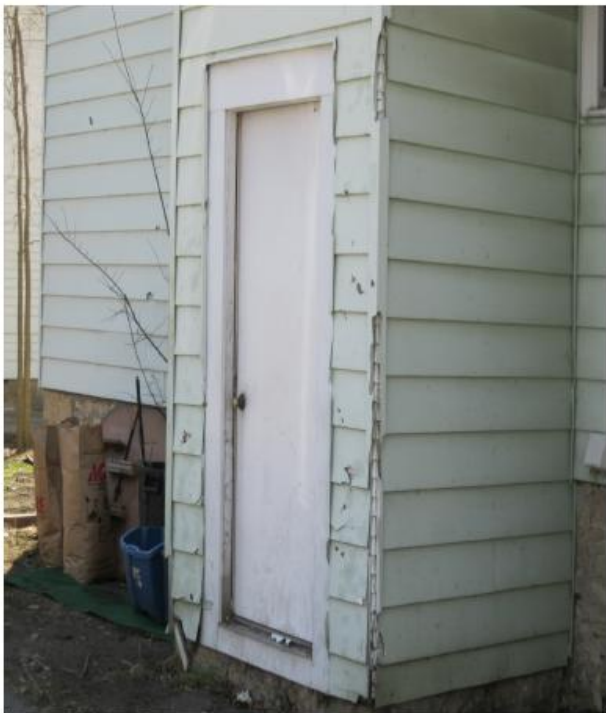
Damaged siding and trim on east side of the property. Photograph taken by Code Inspector on March 30, 2011.

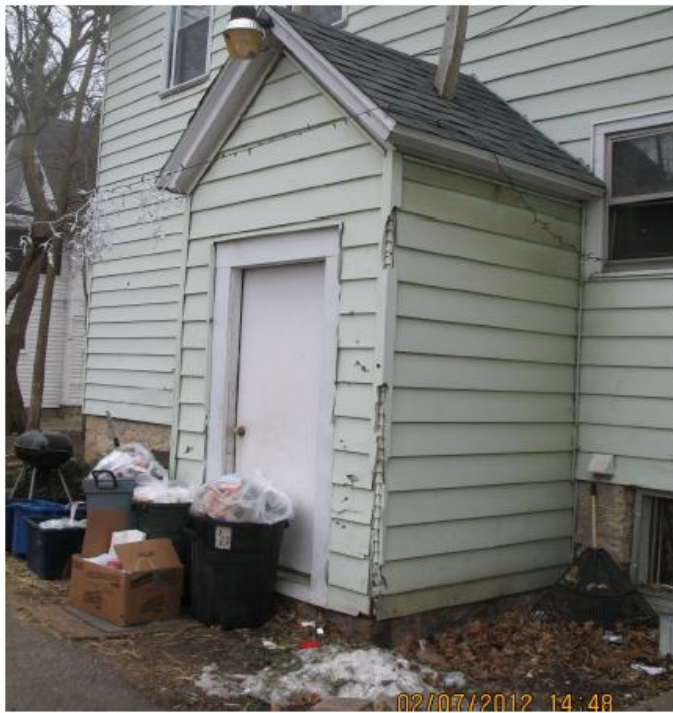
- The applicant has proposed to replace the deteriorated vinyl siding on the basement entryway, located on the east side of the house, with new Main Street Double 4" Woodgrain Clapboard vinyl siding from Certain Teed Corporation. The new vinyl siding will match the existing "mint" color and woodgrain texture siding on the house. In addition, siding near the driveway entry, located on the north side of the house, will be replaced with salvaged pieces of siding from the basement entryway.

Damaged siding and trim on east side of the property.

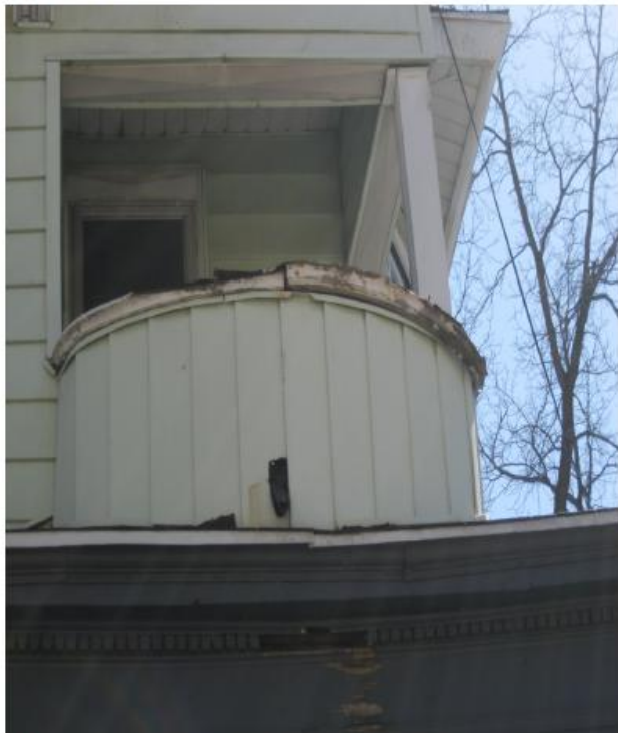
Deteriorated wood and trim on balcony on the northeast side of the property. Photograph take by Code Inspector on March 30, 2011.

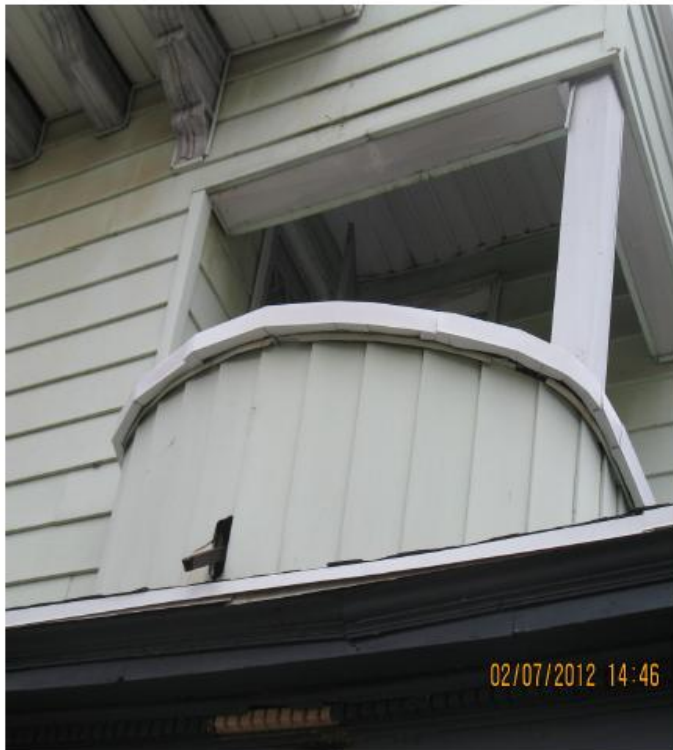
- The applicant has covered the deteriorated wood on the balcony, located on the northwest side of the house, with aluminum trim that is white in color.

Replaced trim on balcony on the northeast side of the property.

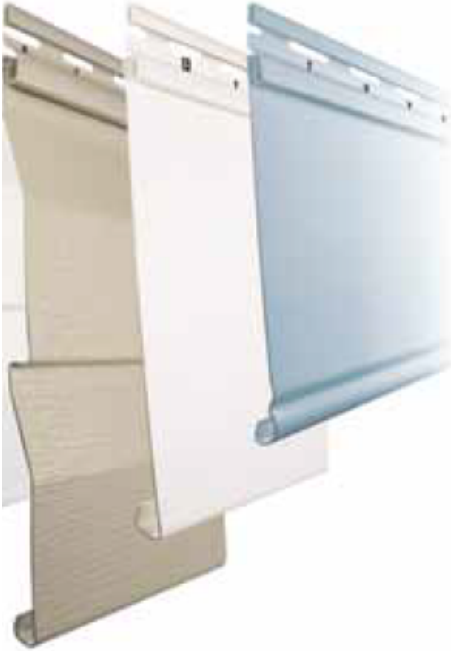
Figure 2: Material Samples Submitted By Applicant

Double 5" Woodgrain Dutchlap in natural clay
 Single 8" Woodgrain Clapboard in colonial white
 Single 6-1/2" Brushed Beaded in oxford blue
