REPORT TO THE BELOIT LANDMARKS COMMISSION

File Number: COA-2018-13

Location: 811 Church Street

Gerri Downing has submitted an application for a Certificate of Appropriateness (COA) to repair stucco sections on the residential structure located at 811 Church Street. This property is located within the College Park Historic District. Section 32.06 of the Historic Preservation Ordinance grants the Landmarks Commission the authority to issue a COA prior to the alteration of structures within a Historic District.

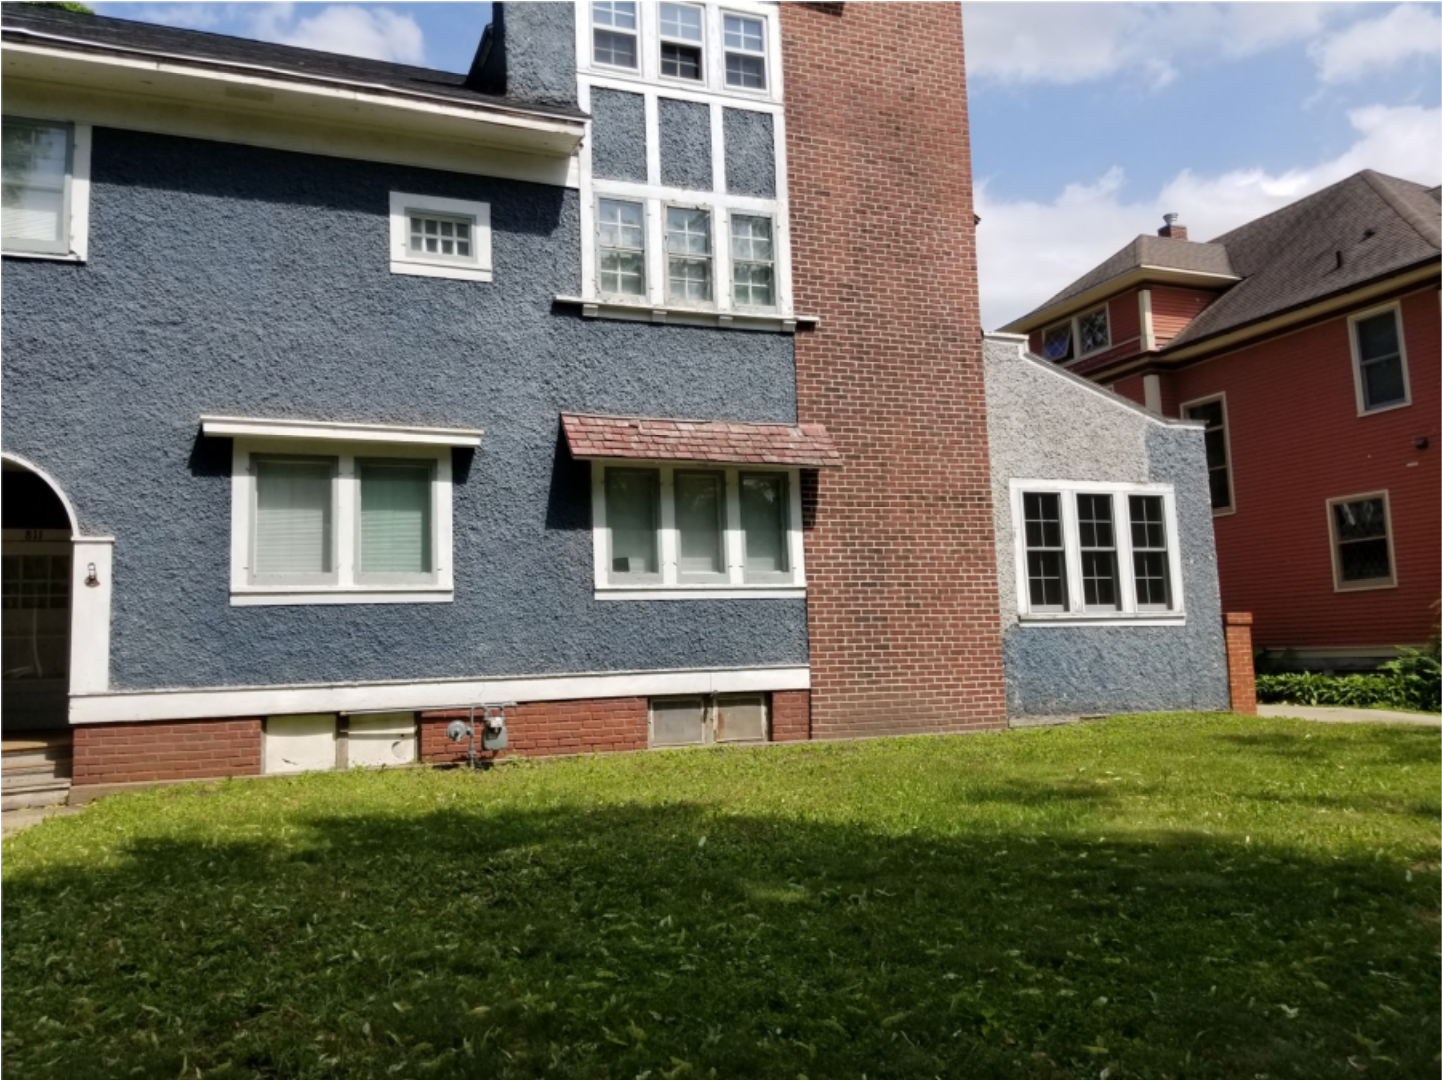
- The attached photo shows the repaired stucco sections, which are nearly identical to the original stucco in texture and appearance. The applicant intends to paint the repaired section to match.

The replacement stucco has been completed in a workmanlike manner and very closely matches the existing stucco exterior of this home. All of the proposed maintenance projects will enhance the appearance and value of the subject property and surrounding properties.
-

1. The repaired section shall be painted to match the remainder of the house by September 1, 2018.
 2. Any changes or additions to this COA must be reviewed and approved by staff prior to the start of any work. Work done without prior approval will be subject to the issuance of correction orders or citations.
 3. The applicant shall obtain all necessary building permits. The completion date above does not extend any other time limits, such as those imposed by an order from an Inspection Official.
-

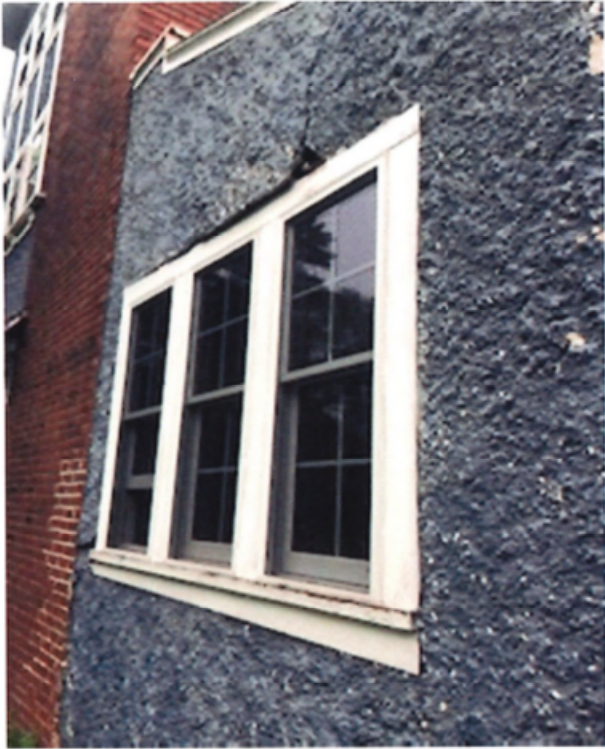
Project #3 – Stucco Repair

Stucco is cracked and coming away from the top of the window and needs to be repaired.

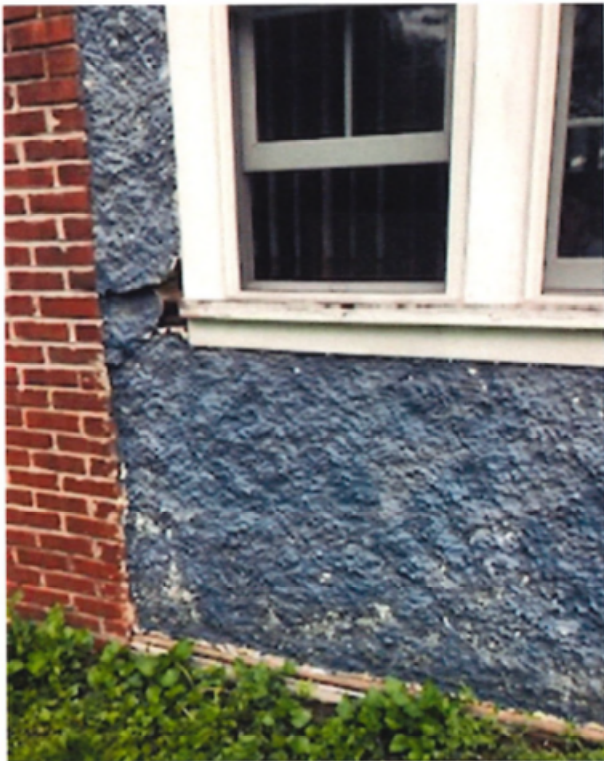
Stucco is cracked and coming away from the side of the window and needs to be repaired.

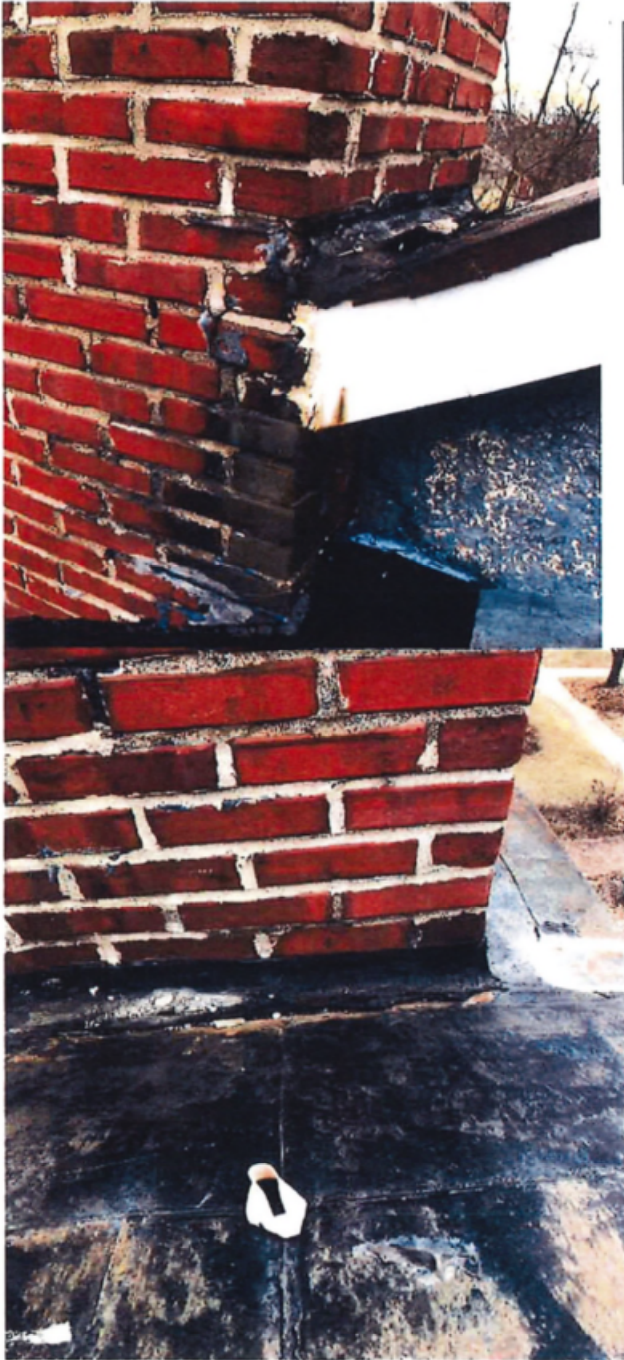
Project #1 – Chimney Repair

Chimney is cracked and needs to be repaired and tuckpointed above the roof line.

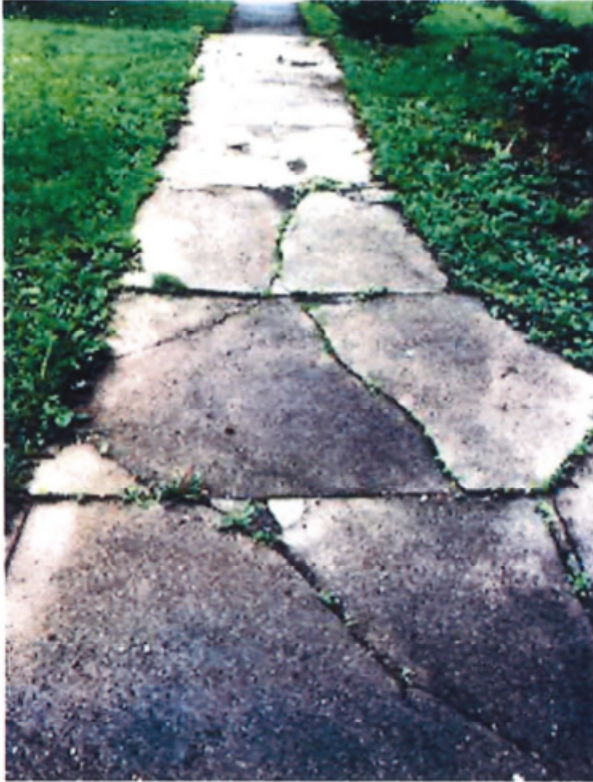
Project #2 – Sidewalk Repair

Walkway from the front door is cracked and uneven. We would replace with the same material (concrete).

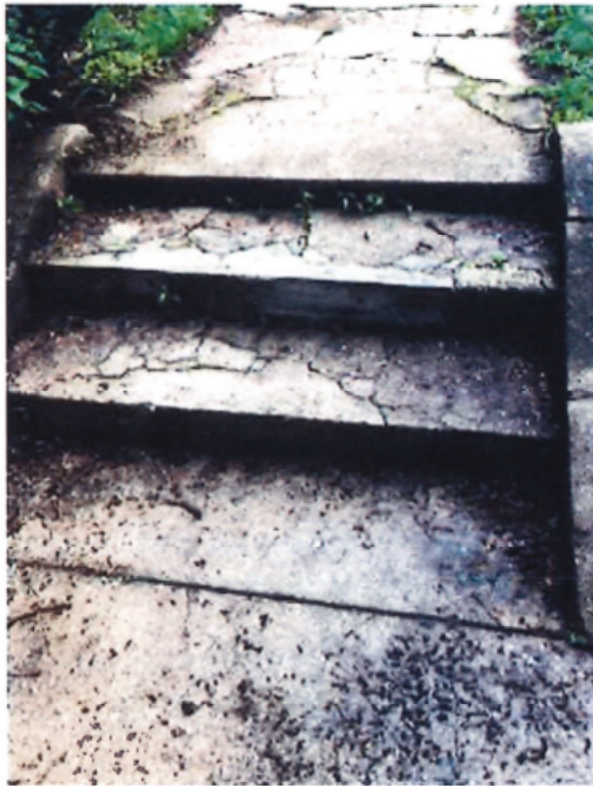
Front steps are cracked and are different heights. We would replace concrete steps with same material and correct step height.
