CITY OF BELOIT

REPORT TO THE BELOIT LANDMARKS COMMISSION

File Number: COA-2009-27

Location: 630 Park Avenue

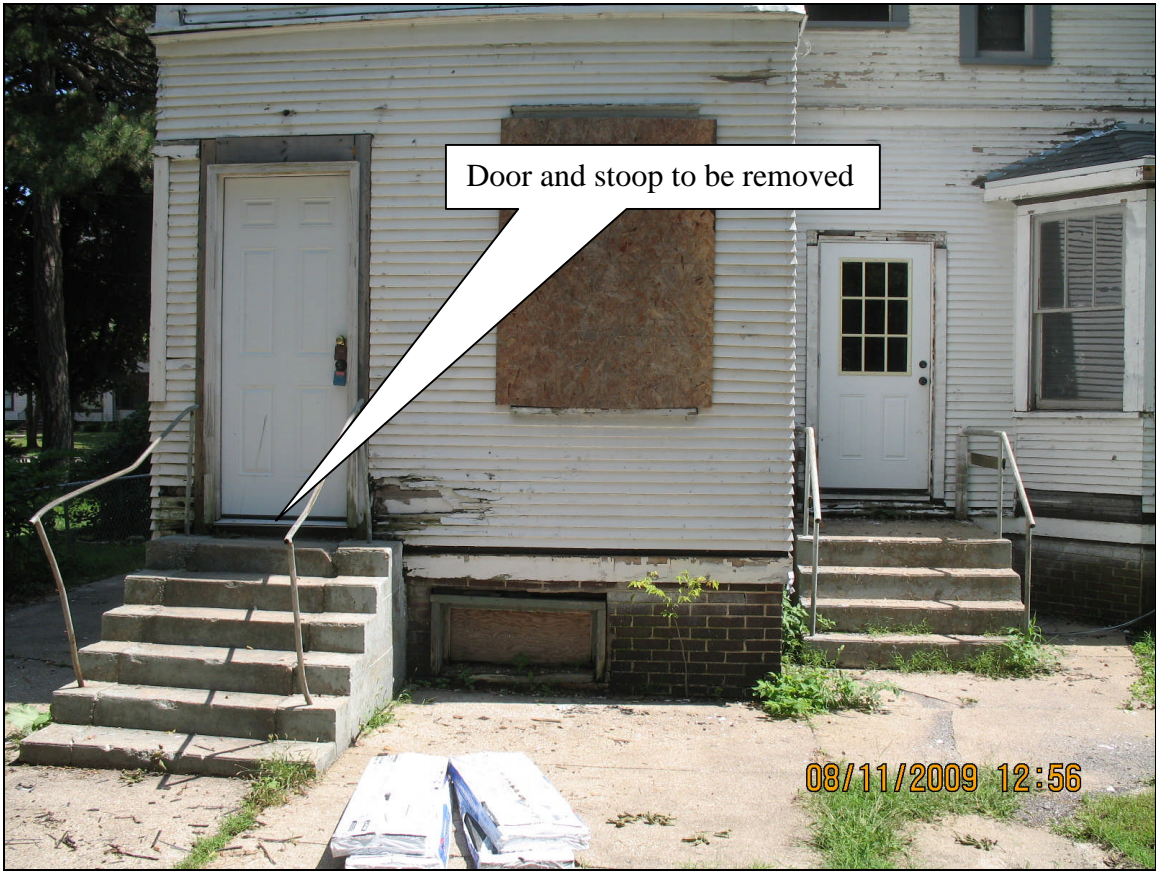
- Several photographs of the house are attached to this report.
- The door and stoop in question are shown in the attached photo. By removing the door and stoop, the applicant intends to improve access to the detached garage. Following removal, the applicant will install siding that matches the siding on the remainder of the house.

Door and stoop to be removed

As stated above, the door and stoop do not face Park Avenue. Removal of the door and stoop will not be detrimental to the character of the house. Removal of the window will restore some symmetry to the northern façade, which is a key feature of this structure. The reopening of a picture window will restore much of the original character of the rear façade.

The Neighborhood Planning Division recommends **approval** of a Certificate of Appropriateness to remove a door & stoop, to remove a window, to replace the front door, and to reopen a picture window for the property located at 630 Park Avenue, based on the standards and criteria contained in the Historic Preservation Ordinance and subject to the following conditions:

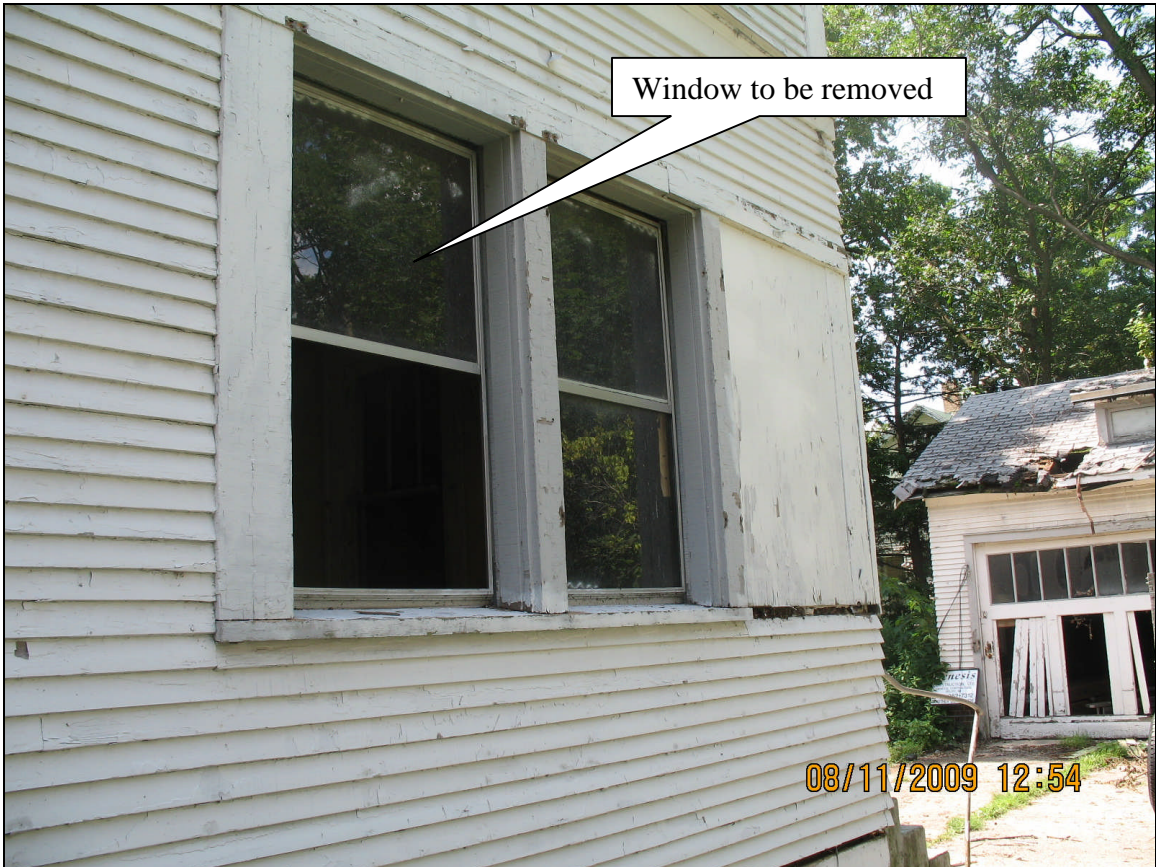
- The applicant has proposed the removal of one window, as shown in the attached photo. By removing the window, the applicant intends to create more symmetry. Following removal, the applicant will install siding that matches the siding on the remainder of the house.

Window to be removed

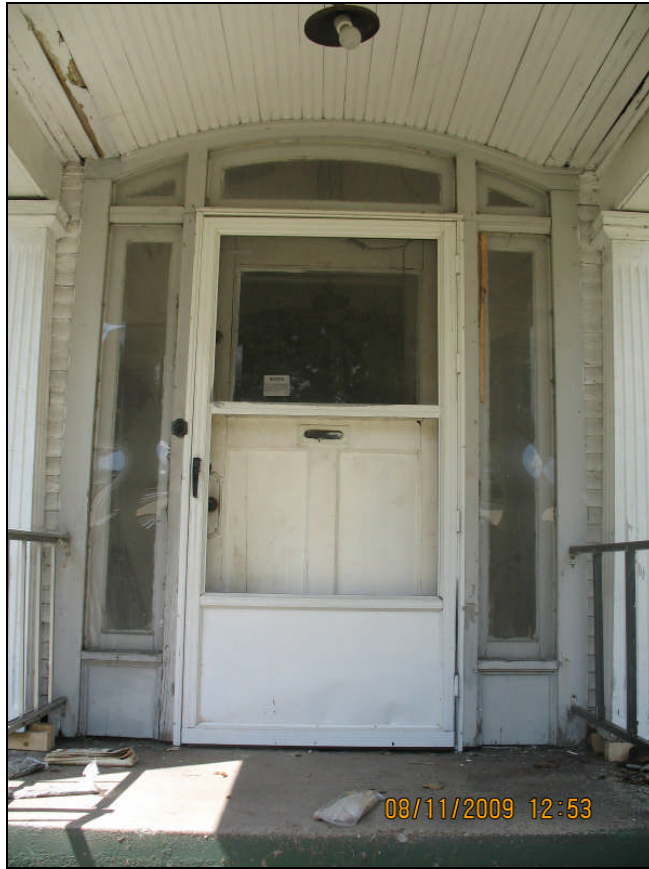
- According to the applicant, the front door is energy inefficient and is in a deteriorated condition. However, as shown in the attached photos, the front door includes a transom. Modern replacement doors are taller than the existing door, and the applicant has stated that he might not be able to locate a replacement door that will fit the existing opening. Therefore, it is likely that the replacement of the front door would result in the removal of the transom.

The arched transom is certainly an important architectural feature, and while staff understands the applicant’s dilemma, staff is reluctant to endorse its removal. Staff is inclined to support the replacement of the front door, but only if the original transom is retained. This may require the purchase of a customized door.

1. The applicant shall install Mainstreet T3 “Brushed Stroke” vinyl siding that is white in color. The original wood siding shall not be removed.
2. The applicant shall install a Silverline picture window that is white in color.
3. The original transom and sidelights shall be retained.
4. All work shall be completed by May 1, 2010.
5. Any changes or additions to this Certificate of Appropriateness must be reviewed and approved by staff prior to the start of any work. Work done without prior approval will be subject to the issuance of correction orders or citations.
6. The applicant must obtain all necessary building permits. The completion date above does not extend any other time limits, such as those imposed by an order from Housing Services.

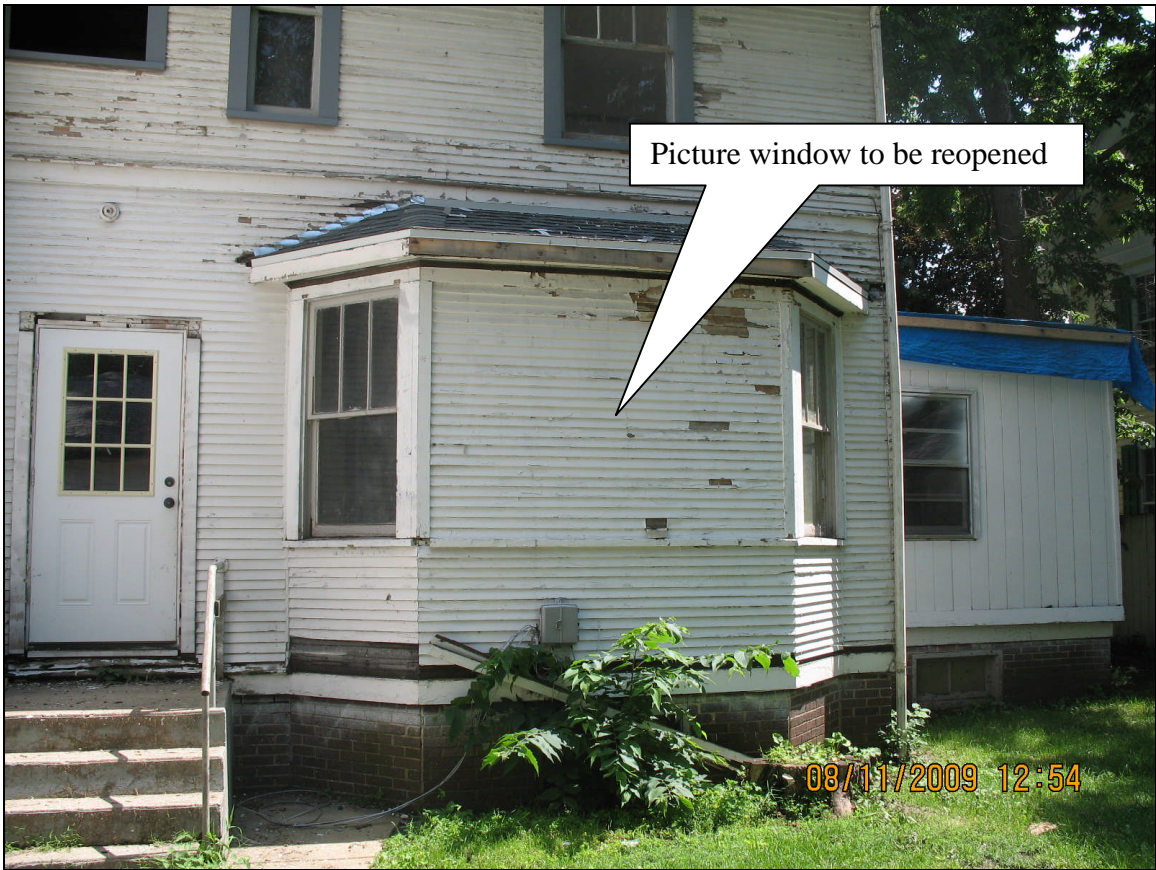
- The applicant has also proposed the reopening of a picture window on the rear of the home, as shown in the attached photo.
- During the Beloit Intensive Survey, the house was classified as a 'contributing' structure within the College Park Historic District. A copy of the Intensive Survey Form is attached to this report.
